Using the Right Connection is a Must in Food and Beverage Industries

BY PHIL KIMBLE

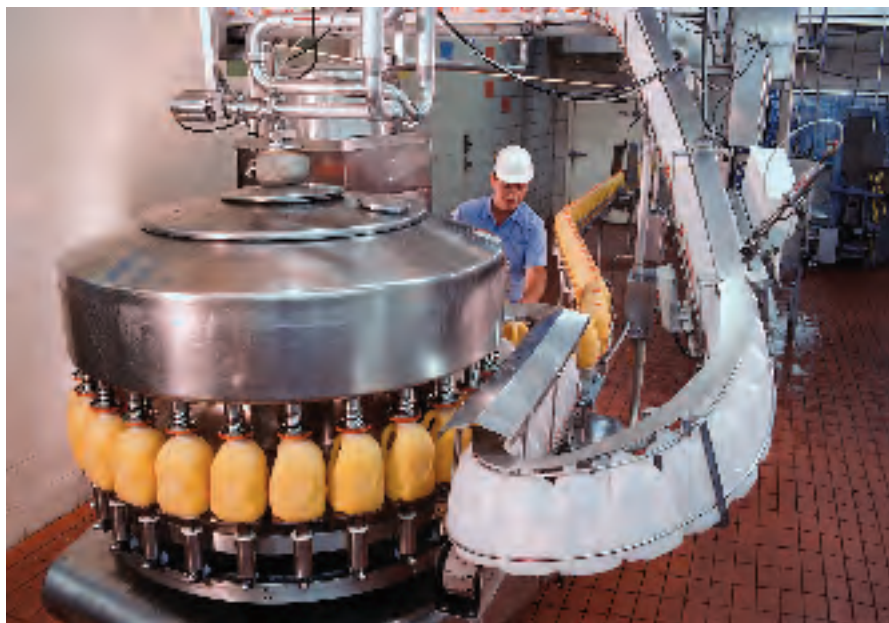
any recent replacements anywhere in the process line. The third shift supervisor answered that he had a couple of his guys replace a leaking hose several weeks ago. Upon inspection of this replacement assembly, both the plant manager and the shift supervisor were shocked to see one end of the assembly with a banded-on coupling. This style of coupling is to be used on the “raw” side of the plant only. Its traditional shank does not conform to Food and Drug Administration standards for sanitary couplings. Even though all CIP cleaning and sanitary procedures were followed after this replacement assembly was put into service, bacteria propagated at the end of this shank contaminated a vast quantity of product.

Improvisation is great for stand-up comedians, not for hose assemblies. Contact your local Dixon distributor for the Right Connection. Remember, you can have your cake, but you might not want to eat it.
